CLINICAL CASE STUDY

A Wheelchair User with Common but Serious Complaints of Back Pain and Sliding or Shear

Susan Cwiertnia, PT, MS

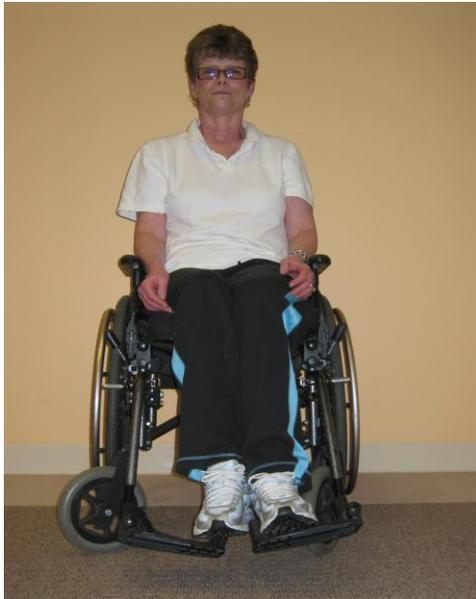
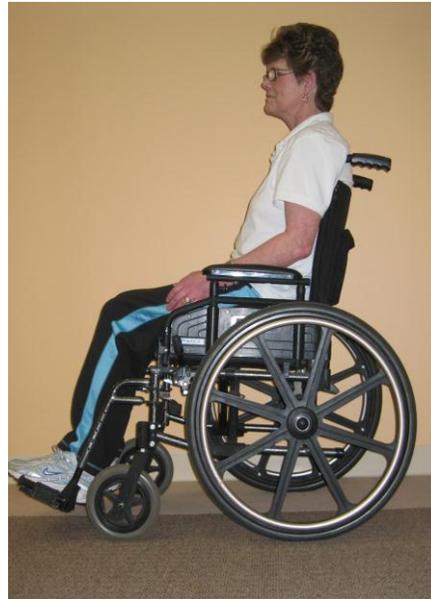
Before pictures of K.L. sitting with her sling back and old Evolution cushion.

K.L. is currently sitting in a high strength, lightweight wheelchair with a sling back and tension upholstery seating that was newly purchased a year and a half ago. She is using a *VARILITE* Evolution PSV™ cushion that she picked out without assistance of a seating professional. With her current equipment, K.L. reports that she has constant back pain and can not sit in her chair for more than an hour at a time. Because of this she transfers in and out of her chair as many as 20 times a day which contributes to her fatigue. She also reports that she can't stay seated back in her chair and is always sliding forward. At this time she does not have any skin integrity issues.

During the evaluation, we were surprised to find that K.L., who is fairly tall and has a buttock/thigh length of 19.5" on both legs, was sitting in a 16 x16" chair and cushion. When asked who measured her for her chair, she responded that no one did. She showed up at the dealer to purchase her new chair. They pointed to an area of the showroom and told her she could "pick out one from those over there".

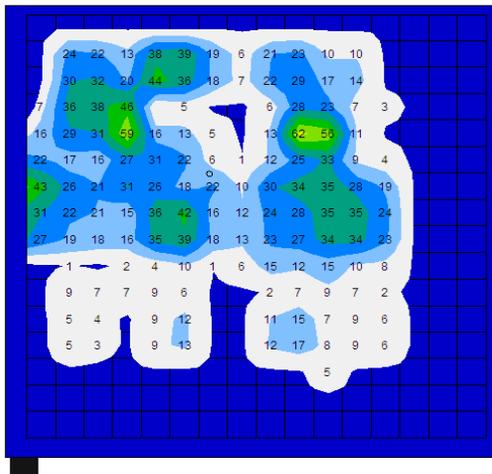
FSA pressure map of K.L. with her sling back and current Evolution cushion. Note the obvious sacral sitting.

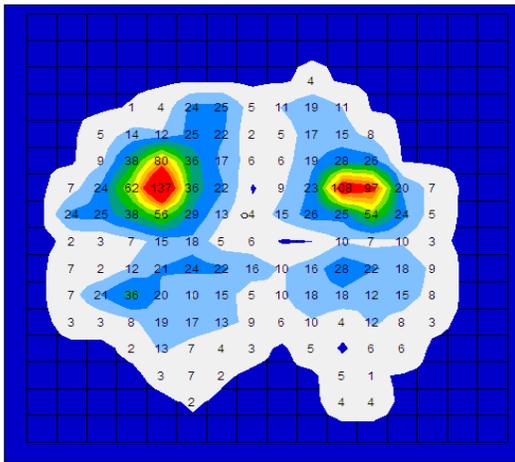
FSA pressure map of K.L. with Evolution Back and Evolution cushion. Note high peak pressure areas of the ischials.

The sling back upholstery was removed from K.L.’s wheelchair and replaced with an Evolution Back™. We did a pressure map of her on her current Evolution cushion with the new solid positioning back. The addition of the solid back greatly improved her sacral sitting but when her sitting position was corrected, K.L. had high peak pressures underneath her ischials and no loading of the thighs.

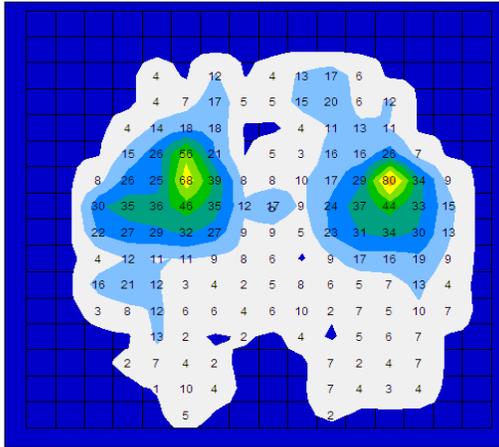
FSA pressure map of K.L. on a 16 x16” Meridian cushion while using an Evolution Back.

To see if we could get some loading onto the thighs and decrease the pressures under the ischials, a 16 x16” Meridian™ cushion was trialed with her new Evolution Back. Overall there was some improvement in the pressure distribution but the decreased seating surface area from a wheelchair that was too short interfered with good results.

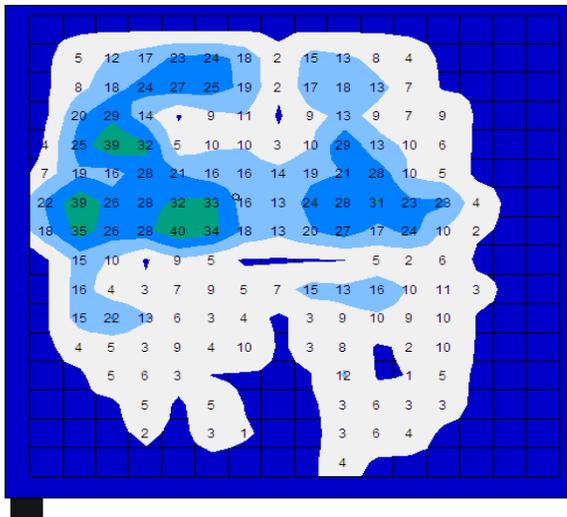
FSA pressure map of K.L. on a 16 x18” Meridian Wave CPB cushion while using the Evolution Back. Note the loading of the thighs, decreased peak pressures of the ischials and improved pressure distribution.

To achieve greater seat depth for postural support and pressure distribution, a 16 x 18” Meridian Wave™ cushion with a Contoured Positioning Base was trialed. The solid base would allow the cushion to extend beyond the tension upholstery of the wheelchair seat and increase the seat depth. K.L.’s seat depth with this cushion was increased to 17.5”.

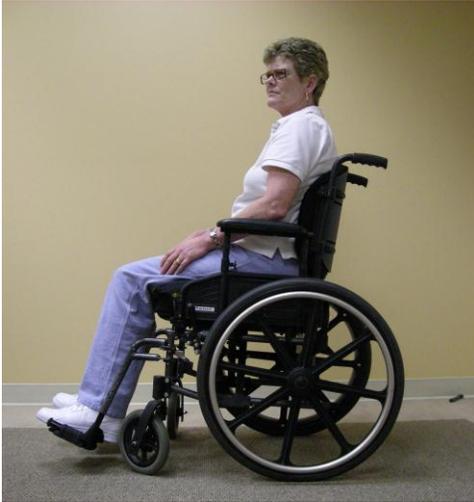
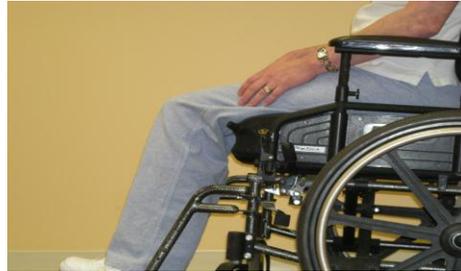
K.L. shown with her Evolution Back and Meridian Wave cushion. The solid base of the Meridian Wave system was used to extend her seat depth.

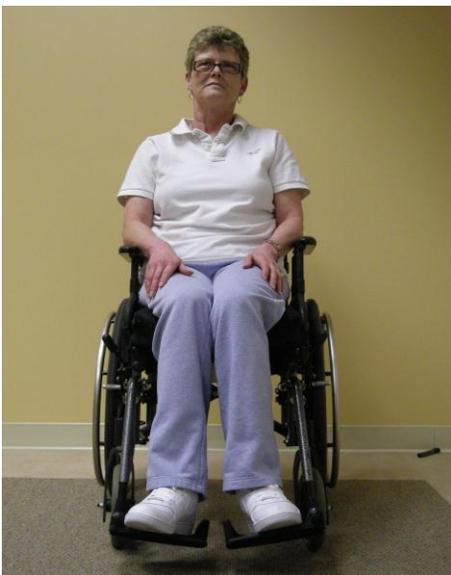
K.L. is no longer sliding forward in her chair.

Many of this end user's problems, which are common complaints frequently heard from many other end users, were resolved or significantly improved by providing better postural support and pressure distribution. During a follow up only weeks after the changes, K.L. was excited to report that she is no longer sliding down in her chair anymore. She is much more comfortable while sitting in her chair and able to sit much longer. Her sitting tolerance has now increased to 2 ½ to 3 hours at a time making shopping, working, and visiting her sisters much more enjoyable. Now K.L. is truly looking forward to her vacation in Mexico this summer.
