Sacral-Ischial

Foam Indentation

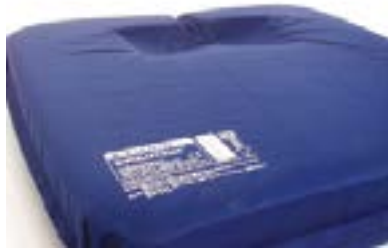
After VARILITE Air-Foam Floatation cushions (such as Evolution PSV™ and Meridian™) have been used a number of times, the sacral-ischial foam area may appear to become indented, as shown.

The cushion has NOT bottomed out, set or failed. VARILITE Air-Foam Floatation cushions are designed to indent in the sacral-ischial area.

- The soft, less firm foam of the sacral-ischial area, by design, exerts less “push back” on the cushion fabric than the surrounding firmer foam.
- The four-way stretch cushion fabric accentuates the indentation.

We recommend that you leave the valve open and allow your *VARILITE* Air-Foam Floatation cushion to fully inflate overnight, at least once a week, to maintain optimal cushion performance.
